Mechanical Tests and Failure Analysis on Selected Components of the Class 60 Armored Vehicle Launched Bridge (AVLB) During the Class 70 Modification Program

ARL-TR-1269

December 1996

Weapons and Materials Research Directorate, ARL

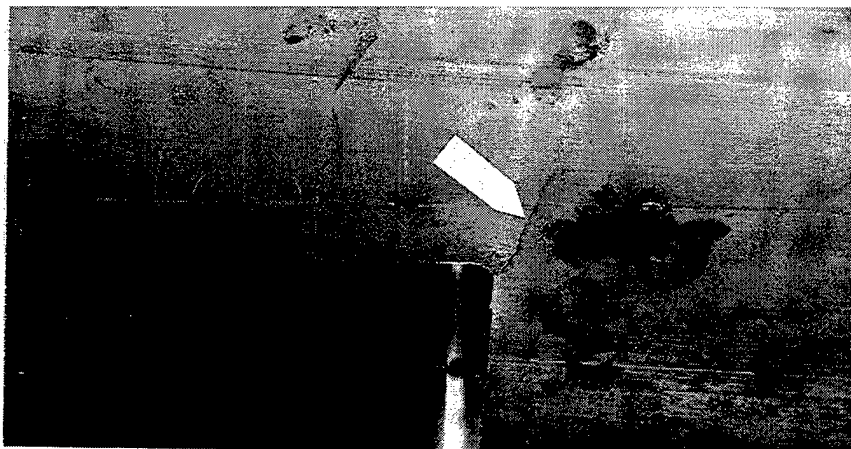
Figure 6. A close-up view of a crack (arrow) at the corner radius of the bottom chord inner aluminum angle where its horizontal leg was cut off to accommodate the thicker bottom flange (dark area in lower left-hand corner of the photograph of the inboard steel beam girder. Magnification: 1.28x.

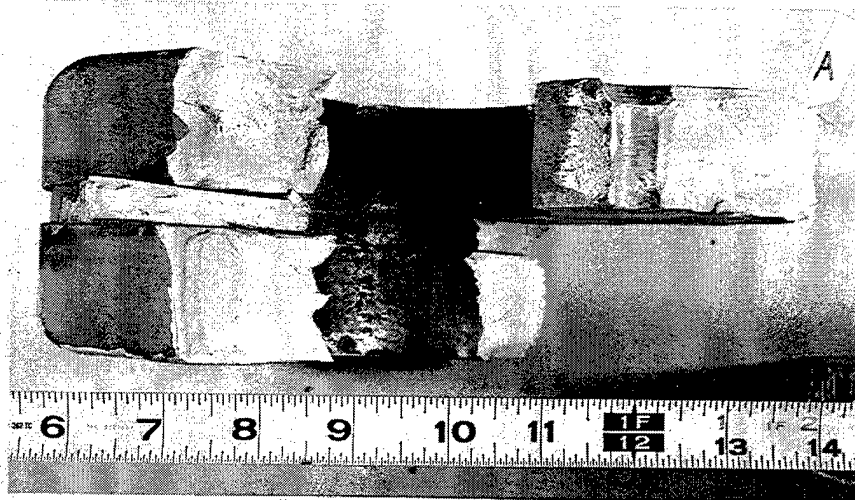
Figure 8. Top view of the broken section in Figure 7, showing the fractured surfaces. Two forged aluminum connector parts were riveted to a 3/8-in-thick inboard girder web aluminum plate (between the forged parts). The top broken piece is a section of the forged inboard connector part, whereas the bottom piece is a section of the outboard connector part. The location at A is the origin of the brittle failure.

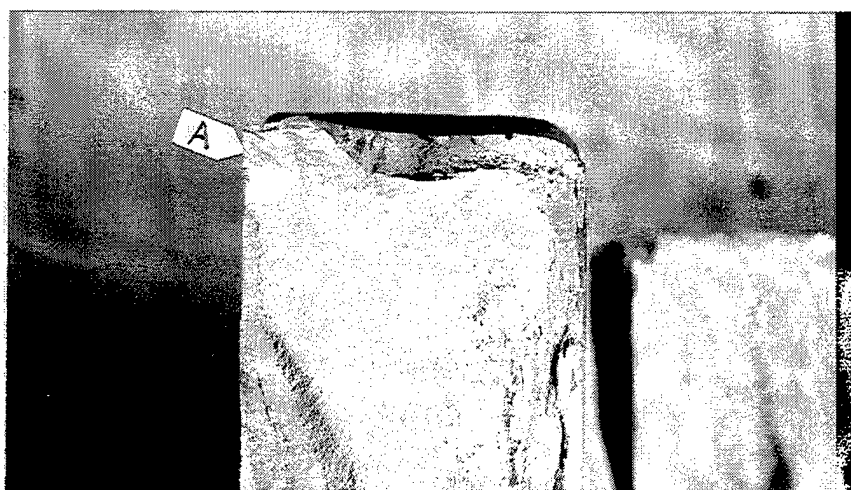
Figure 10. Close-up view of the same area in Figure 9, but under a different lighting condition to show the light-discolored area at the failure origin (A), indicating a fatigue crack. Magnification: Approx. 1.5 \times .

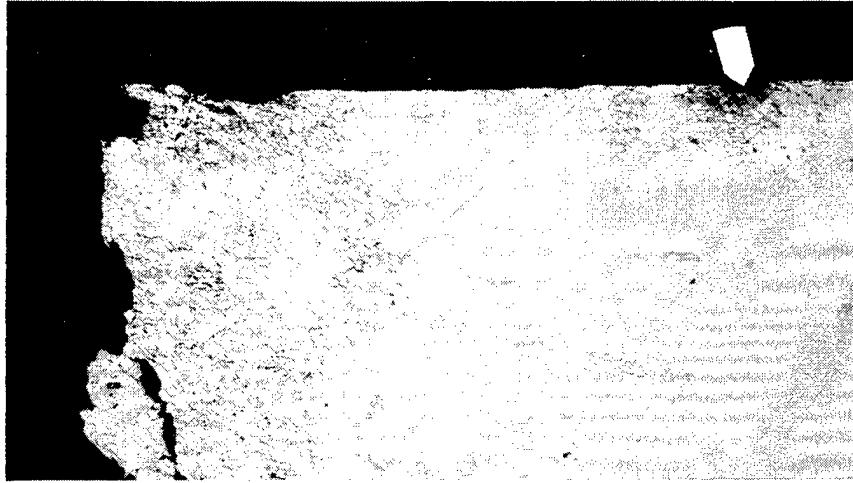
Figure 16. As-polished microstructure of the intergranular corrosion adjacent to the primary fracture (left side) and at a small surface corrosion pit (arrow) in the surface of the eyehole. The metallographic specimen was cut from the failure origin containing the fatigue crack. Magnification: 185 \times . Unetched.

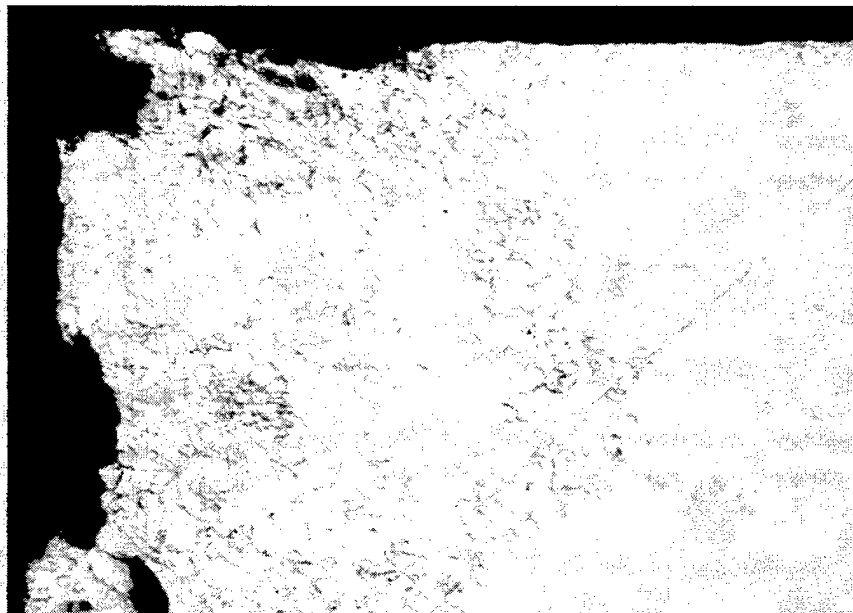
Figure 17. Same area in Figure 16, but at a higher magnification. Magnification: 365 \times . Unetched.

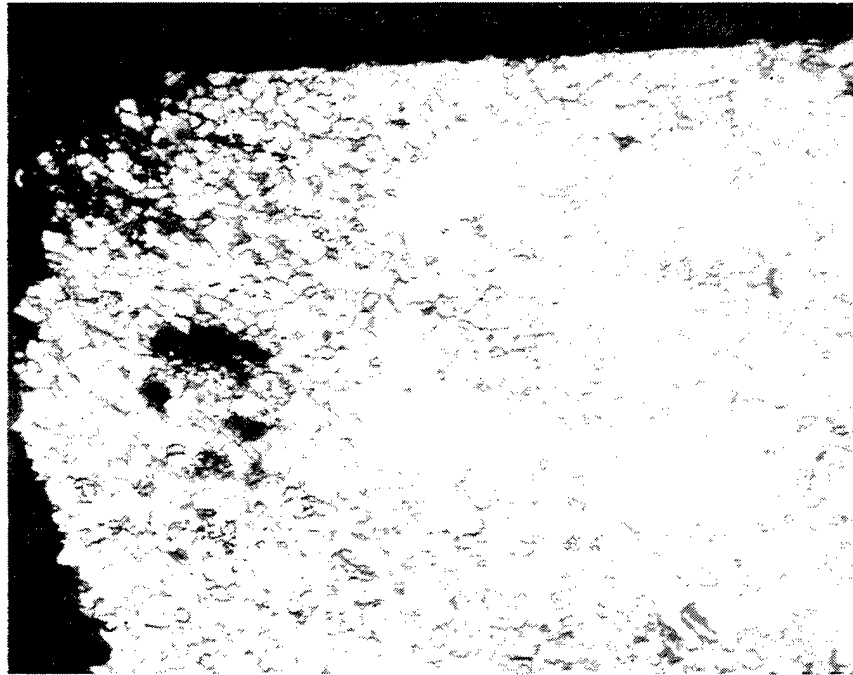
Figure 18. Same area in Figure 17, but etched to reveal the grain structure. Magnification: 365x. Keller etchant.

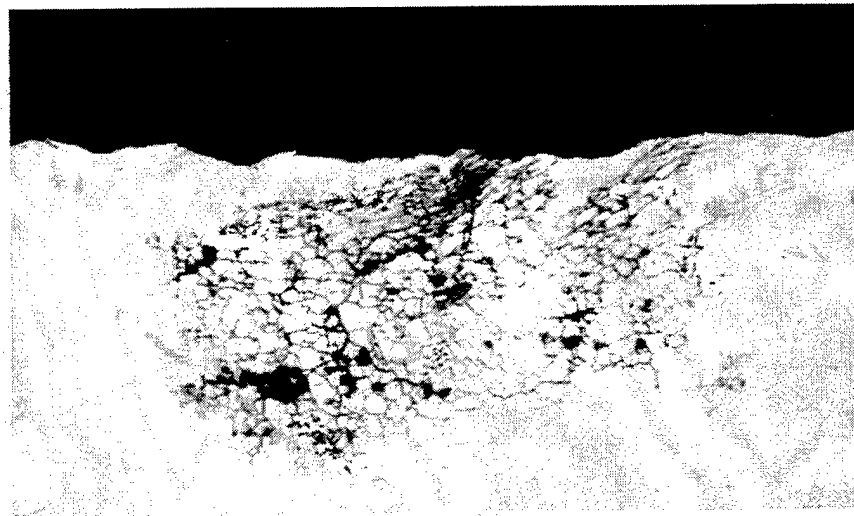
Figure 19. Enlarged view of the intergranular corrosion in a small corrosion pit in Figure 16. A small pit was started in the worn, bare surface of the eyehole, whereby intergranular corrosion spread out internally. Magnification: 365x. Unetched.

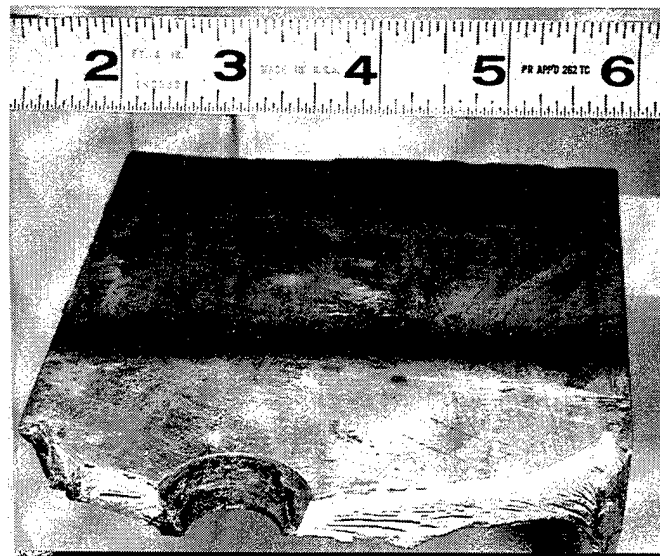
Figure 21. A view of the fractured surfaces of the right section of the broken angle in Figure 20.

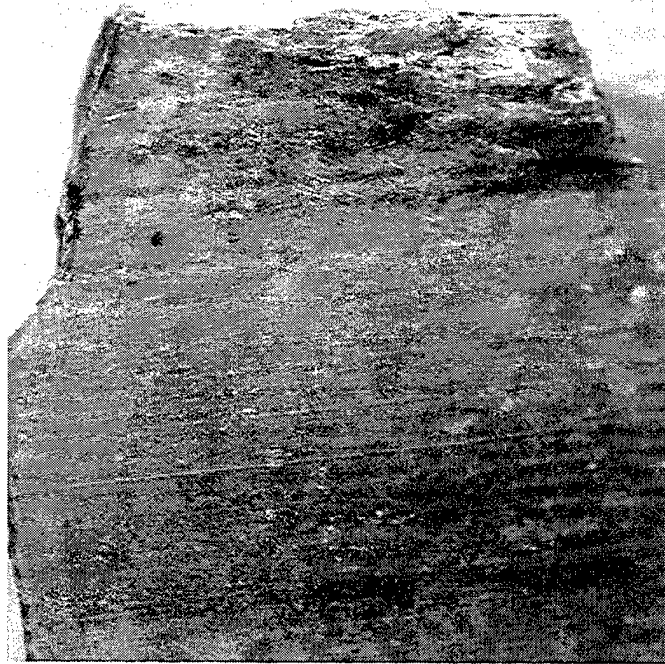
Figure 24. Enlarged view of the rivet hole edge with a crack (arrow) in the small angle piece (A) in Figure 20. Magnification: 15 \times .

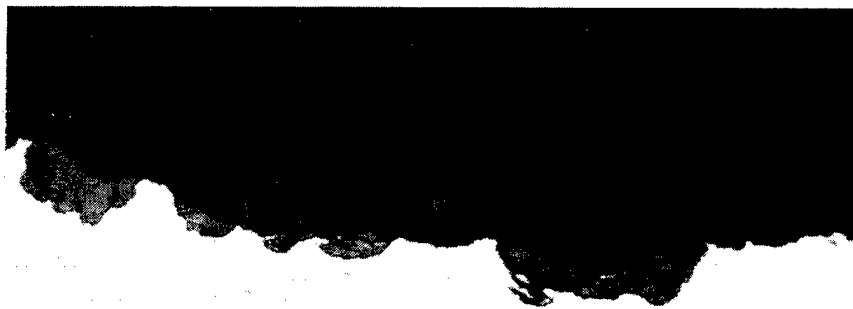
Figure 30. The bottom of the surface pit in Figure 29. The dark gray corrosion products embedded in the bottom, which account for the black color on the top surface of the angle. Magnification: 280x. Unetched.

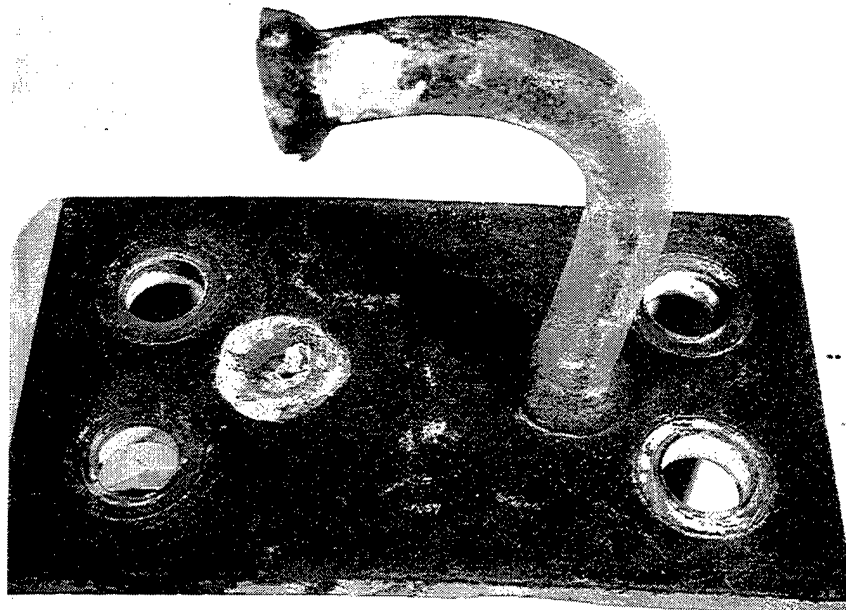
Figure 48. A view of the failed tie-down device after its removal from the test jig in Figure 47.

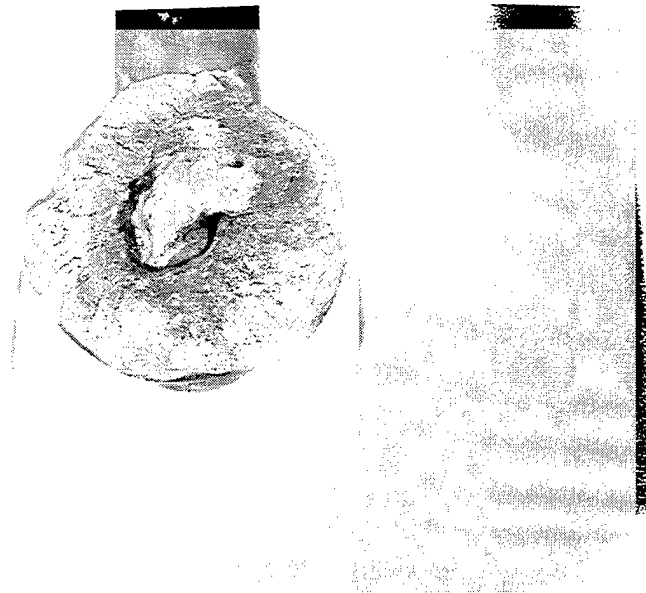
Figure 49. Enlarged view of the weld fracture of the failed end of the bar in Figure 48. Only the central portion of the bar end was truly fused to the base plate. The remaining area of the fracture was essentially cold fusion with very little weld penetration into the base plate.

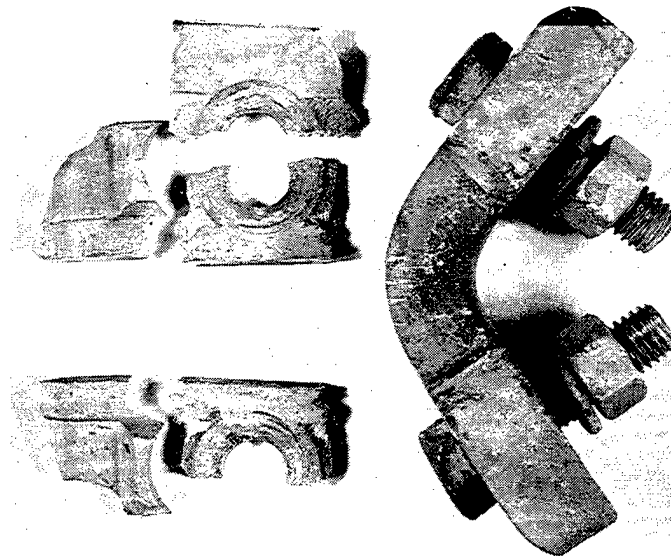
Figure 59. Broken pieces from the bolt holes at the oblong hole in the deck panel plus the bent lifting bar as the result of the pull test. Although not clearly seen in the photograph, discolored areas were observed in the fractured surfaces of the pieces.

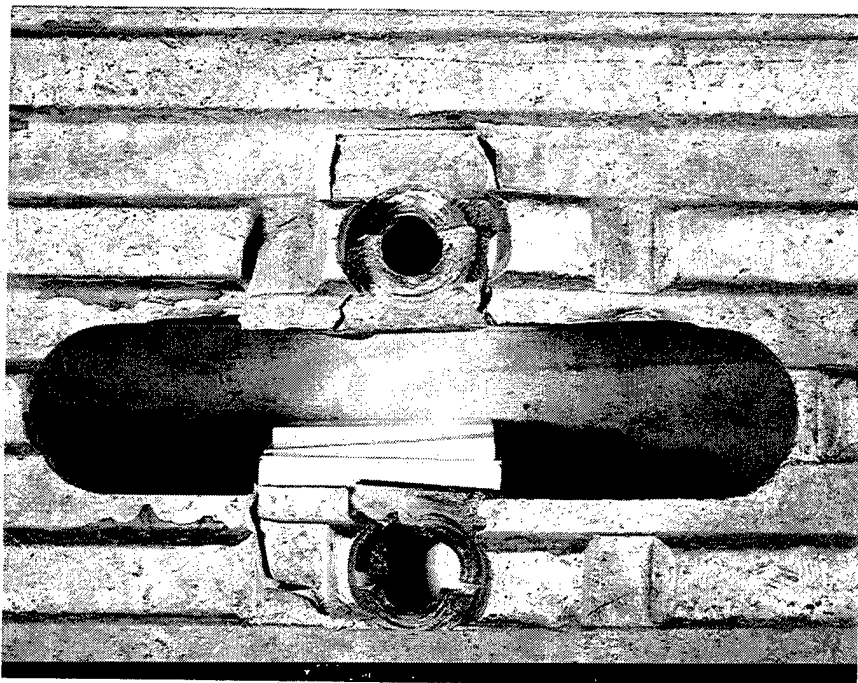
Figure 60. Broken deck panel pieces put back in place in the damaged oblong hole in Figure 58.

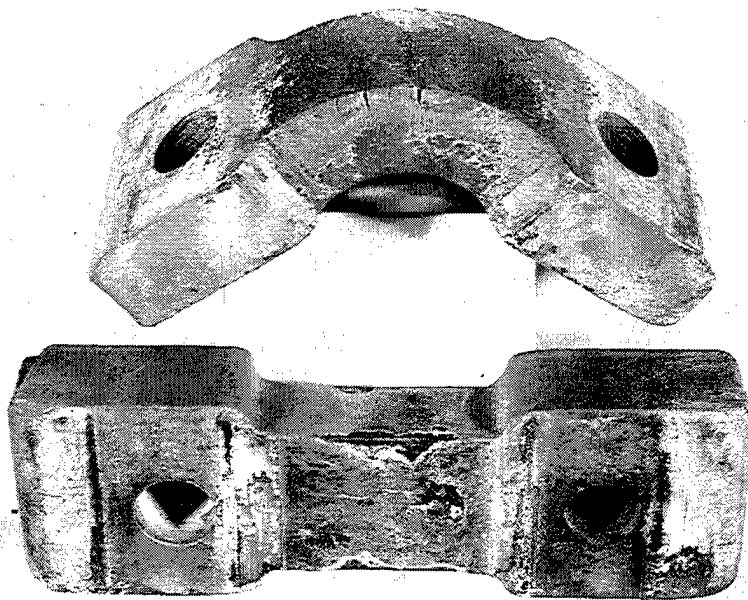
Figure 62. Comparison of the bent lifting bar (top) after the pull test to the straight bar. Note the "dogbone" shape of the lifting bar.

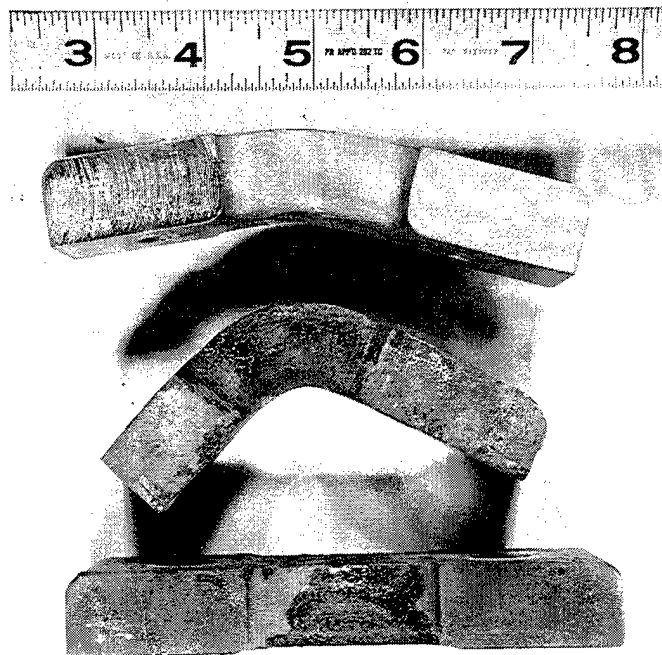
Figure 65. Edge view of the lifting steel bars revealing the extent of bending to the top two bars after the pull tests. The bottom bar served as the reference part that had not been tested for comparison. The middle bar was the original bar made of specified ASTM A 36 structural steel. It was used in the first test that went to 20,250 lb maximum at the time of the failure. The top bar was the new stronger bar made of T-1 steel material. It was used in the second test that went to 28,500 lb maximum at the time of the failure.

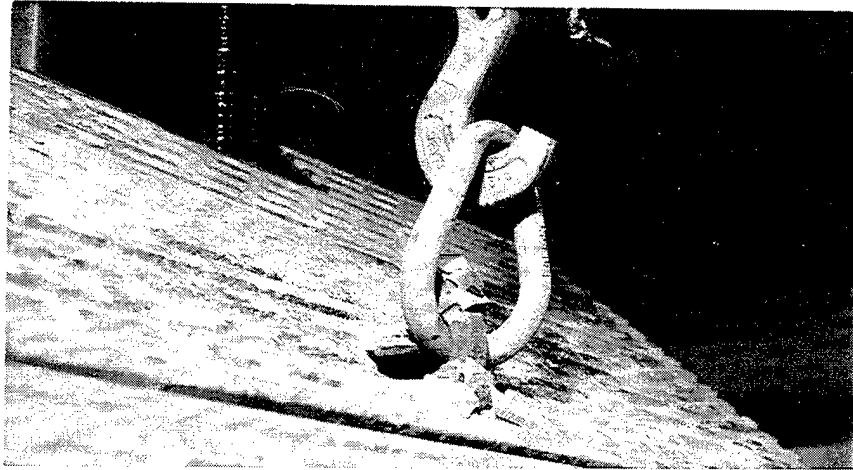
- Third pull test: This test was performed on the lifting device with the original mild steel lifting bar in another deck panel in order to determine the maximum load at the time of the device failure, provided that no pre-existent cracks were present in the bolt holes at the oblong hole in the panel as had happened to the panel in the first test. The test was performed in the same manner as the previous two tests, still using the same large AVLB section attached to the testing machine. The lifting device with the original lifting bar failed at 23,500 lb maximum in this test as compared to 20,250 and 28,500 lb in the first and second tests, respectively. The bar had bent at the steel ring (see Figure 66).

Figure 66. Damage to the original lifting device at the oblong hole in the AVLB deck panel after the third pull test. Note that the lifting steel bar was bent slightly around the egg-shaped steel ring.

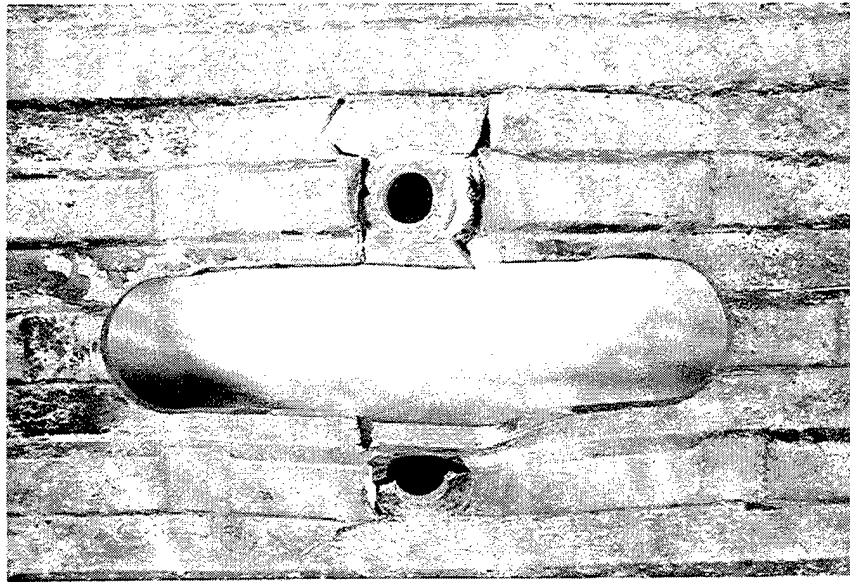
Figure 68. Same close-up view of the damaged oblong hole in Figure 67 after the removal of the lifting bar, bolts, and steel ring.

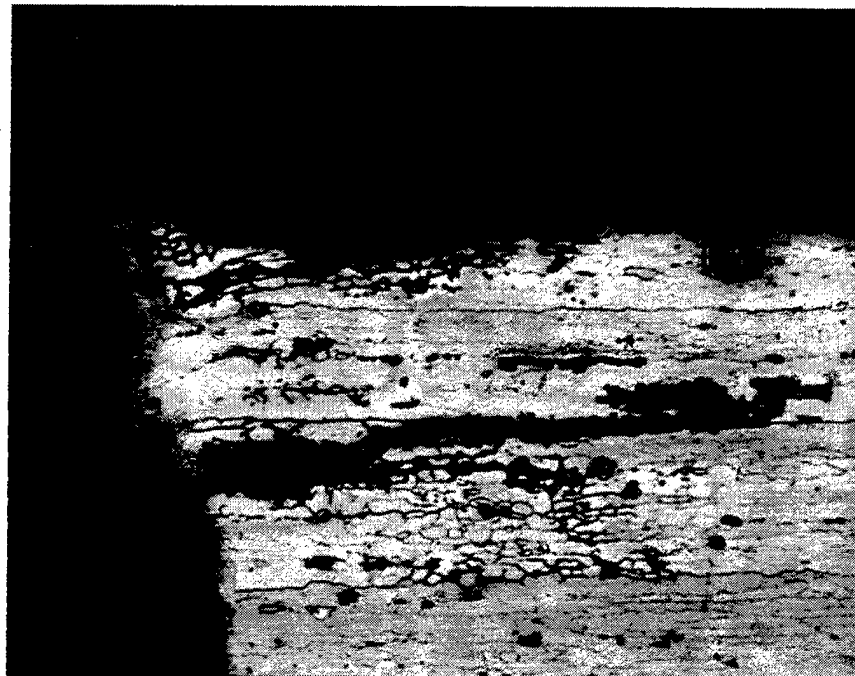
Figure 78. As-polished microstructure showing intergranular corrosion and cracks adjacent to the fracture at top. The vertical side on the left of the microstructure is the wall surface of the counterbore hole, and the slight curvature at the upper left is a portion of the sharp fillet at the bottom of the hole where a crack was initiated because the sharp fillet acted as a stress raiser. Magnification: 380x.

Figure 79. Etched microstructure of the same area in Figure 78. Magnification: 380x. Keller's etchant.

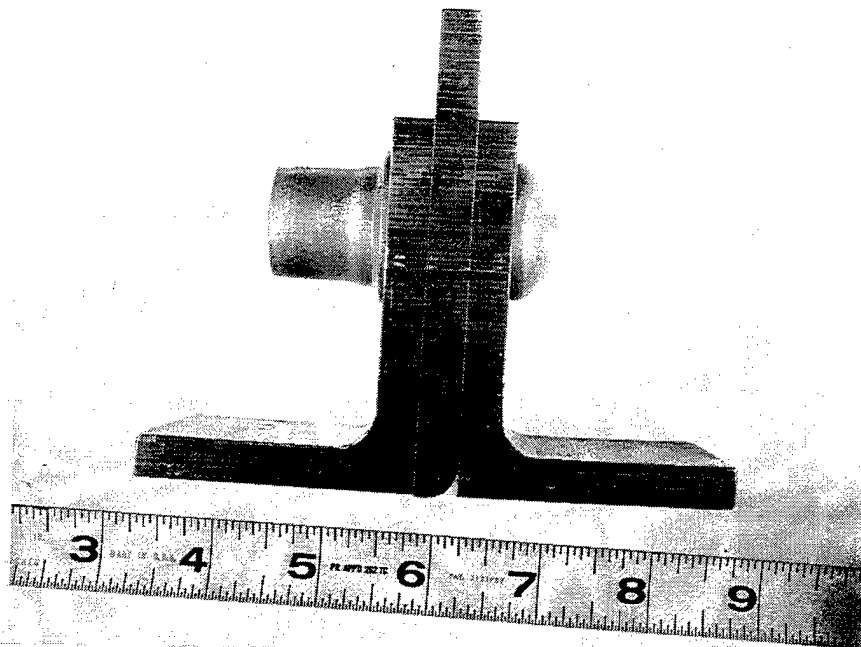
- (1) Specimen A with a fully swaged collar (see Figure 83).

- (2) Specimen B with a fully swaged collar (see Figure 83).

Figure 83. Shear test specimen with the Huckbolt fastener. The center piece will serve as a plunger to shear the shank of the pin during the test. The collar is fully swaged. Note the amount of deformation that had occurred on the outside wall of the collar during the swaging process by the tool anvil.

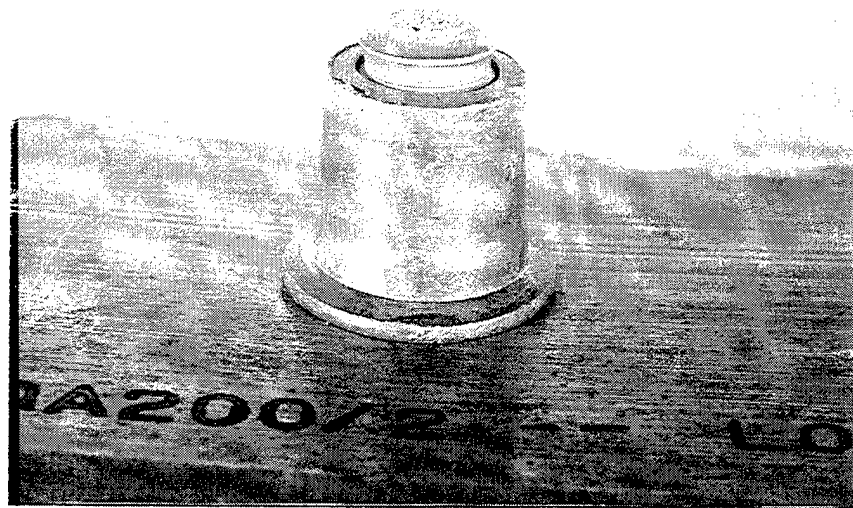
Figure 84. Fully swaged collar of the Huckbolt fastener after the installation. Note that the grip stem portion of the pin was already broken off at the end. (Test Specimen G)

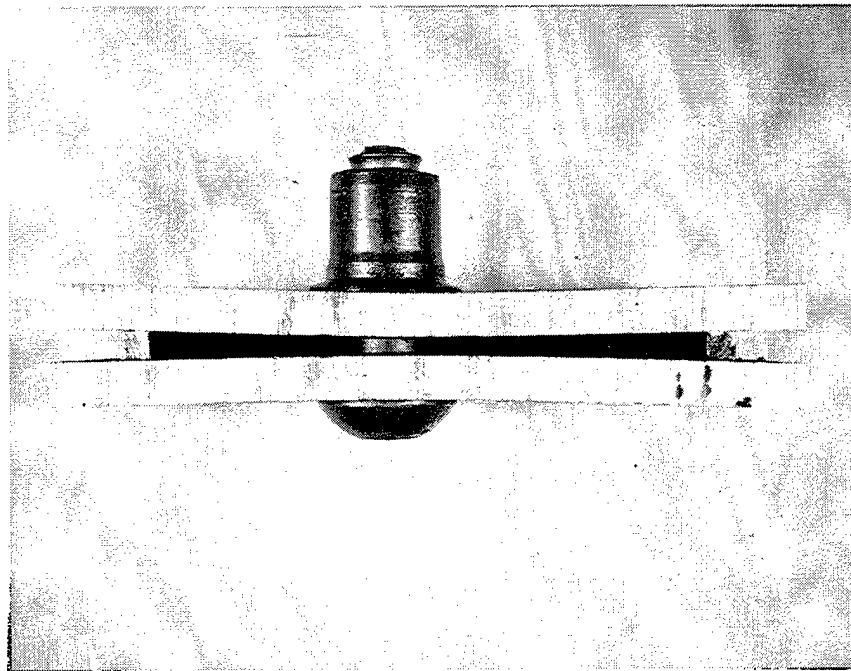
(3) Specimen G installed with two 1/4-in-square steel bars to serve as spacers between two angles to form a 1/4-in gap (see Figure 85).

A special push test was performed on Specimen G with the 1/4-in gap in order to determine the amount of load required to deflect two vertical angle legs to the same deflection that occurred by the clamping force of the Huckbolt fastener installed during the demonstration at the Army depot. After the test to push out the grooved end of the pin from the swaged collar, Specimen G was set up again in the testing machine in a manner so that the two vertical legs separated by the same two 1/4-in-square steel bars could be compressed together by the same amount of deflection seen in Figure 85. With the aluminum collar in place above the hole of the top angle leg to simulate the clamping action, a load of 2,900 lb was required to compress the two angle legs together to 0.080-in deflection in the 1/4-in gap. This would be the approximate clamping force applied by the 3/4-in-diameter aluminum Huckbolt fastener during installation.

Figure 85. Edge view of the Huckbolt assembly test Specimen G. Two 1/4-in steel bars were used as spacers to form the 1/4-in gap between the angle legs. Note the amount of deflection in both legs when the fastener was installed to show the clamping action during the installation.

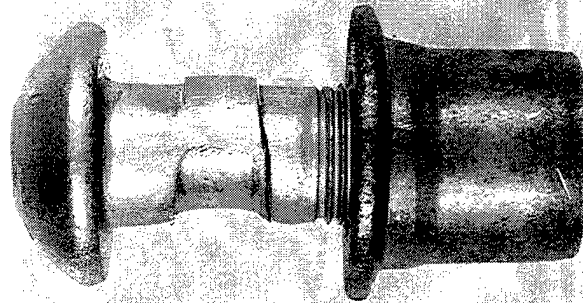
Figure 88. Double-sheared Huckbolt fastener from shear test Specimen A after the shear test. The collar was fully swaged. Actual size.

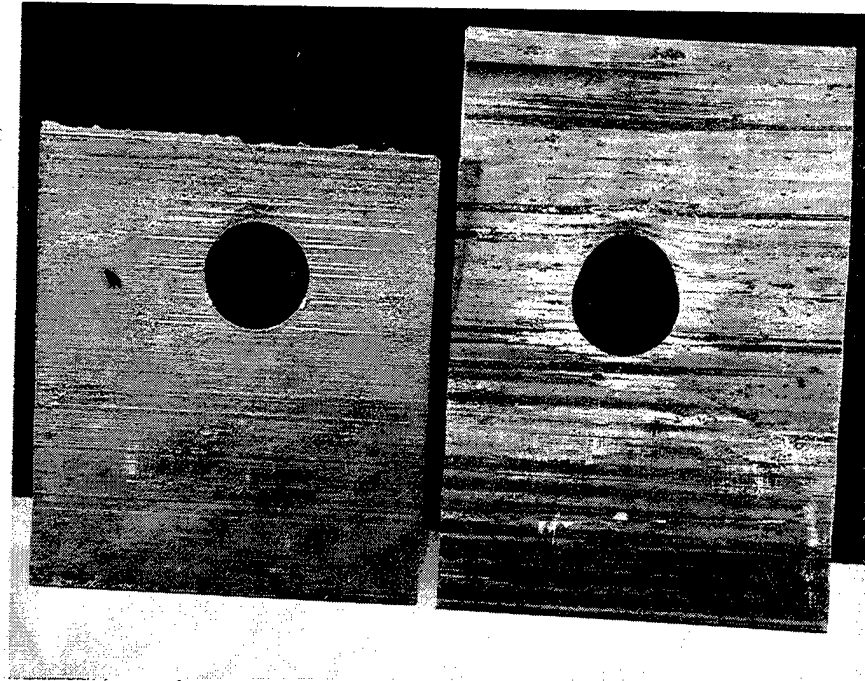
Figure 89. The effect of the shear test on the holes in shear test Specimen A. Note the elongated hole in the center piece (plunger) on right and very little elongation in the hole of the angle leg on left.

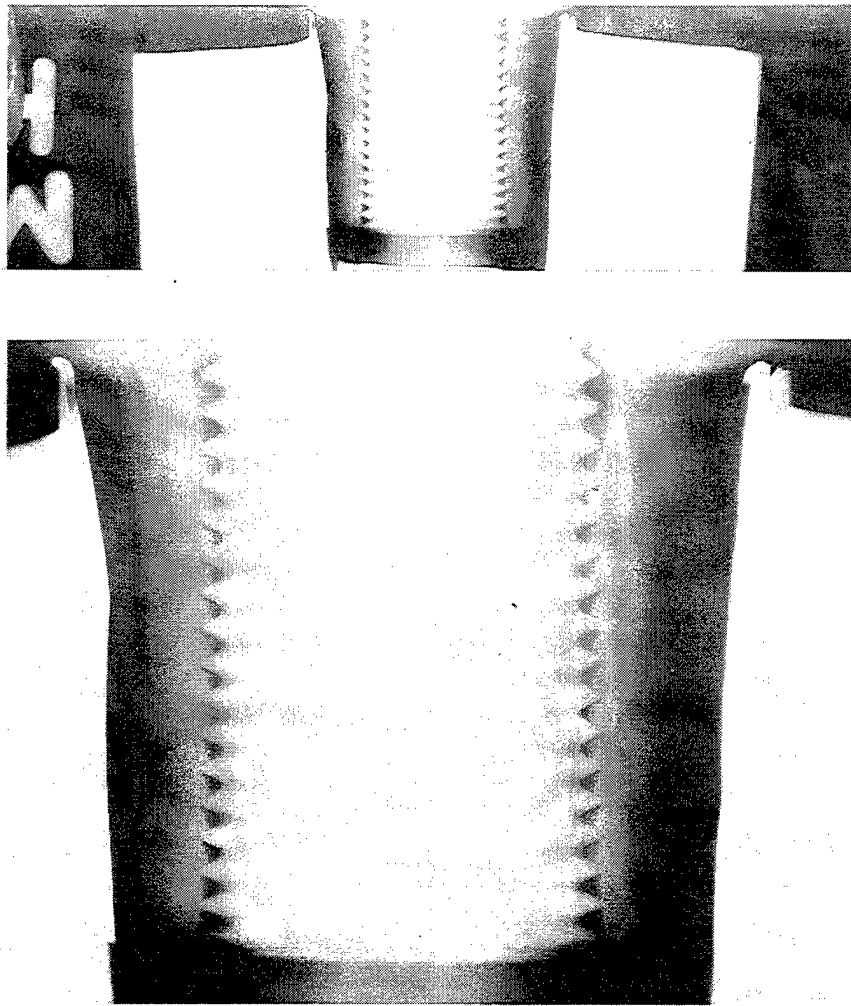
Figure 94. Photographs of a radiographic image of the collar fully swaged on the locking groove portion of the Huckbolt fastener pin. Shear test Specimen F. The push test was stopped at a 21,350-lb maximum load before the complete shearing of the collar interior wall. Note partial shearing of the wall in the image. Actual size (top). Magnification: $2\frac{2}{3}\times$.

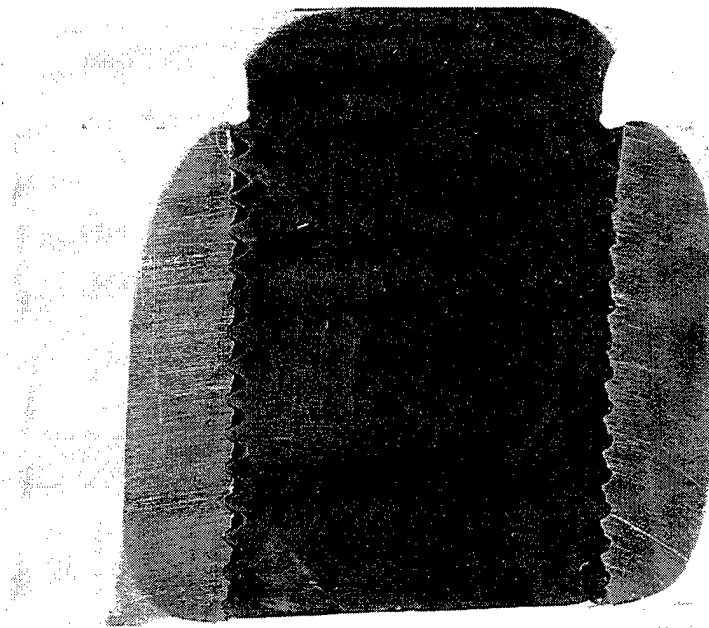
Figure 96. Cross sections of the Huckbolt pin with the locking grooves and the fully swaged collar showing the initial deformation in the collar interior wall penetrated by the tips of the locking grooves. The push test of Specimen F was stopped after the maximum load of 21,350 lb was reached and before the indented interior wall was to be stripped completely by the pin-locking grooves. See Figure 97 for the enlarged view. Magnification: 2.7x. 600-grit surface finish.

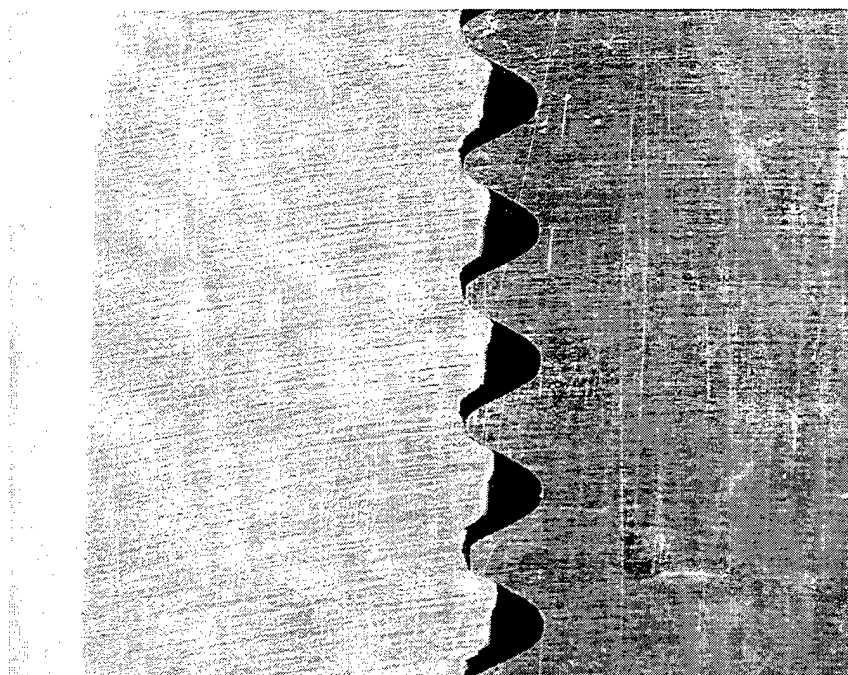
Figure 97. Enlarged view of the cross sections of the Huckbolt pin (right) and collar seen in Figure 96. Note the initial deformation of the indented interior wall of the collar. Magnification: 15 \times . 600-grit surface finish.

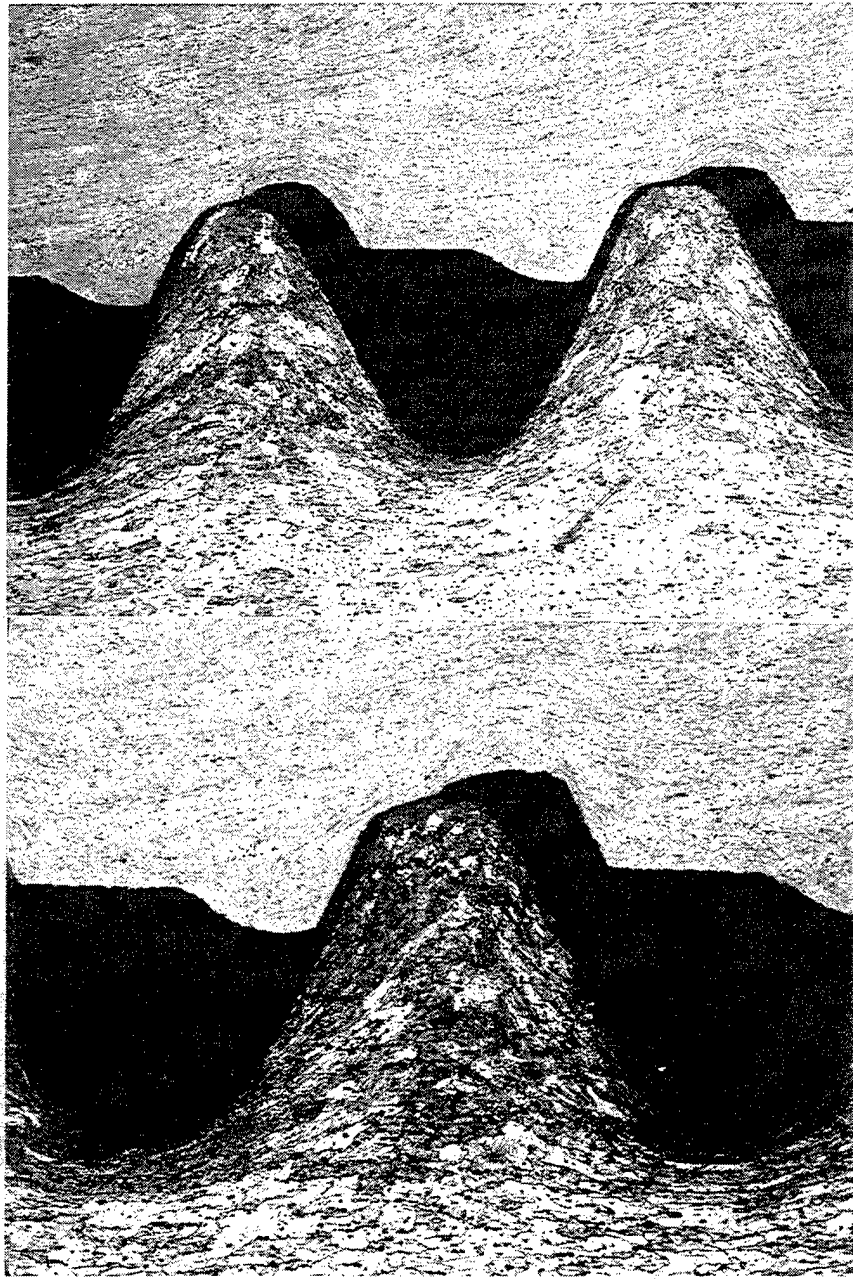
Figures 98 and 99 show the etched microstructures of the swaged collars and pins from Specimens F and D. Deformed grain structure can be seen in the pin-locking grooves, indicating that the grooves were cold-rolled on a portion of the pin shank by the manufacturer. Figure 100 is the sketch of the hardness survey made across the portions of the swaged collar and grooved pin of Specimen F. The hardness was higher in the cold-rolled groove tip, which explained why the locking grooves were not damaged when they penetrated and sheared the interior wall of the swaged collar during the push test. The collar was softer than the pin to permit ease of swaging during the installation of the Huckbolt fastener. Partial penetration of the pin-locking grooves into the interior wall of the swaged collar instead of full penetration was sufficient for the clamping or holding purposes for the intended application.

Figure 98. Two magnifications of the etched microstructure of the Huckbolt-pin-locking grooves (bottom of both photographs) and the indented interior wall of the swaged collar of Specimen F in Figures 96 and 97. Note the deformed grain structure in the locking grooves because of the cold rolling of the grooves on the pin. Also note the buildup of the metal in the interior wall of the collar by the penetrated grooves just after the maximum load was reached and before complete stripping of the indented wall had occurred. Magnification: 40 \times (top) and 50 \times (bottom). Keller's etchant.

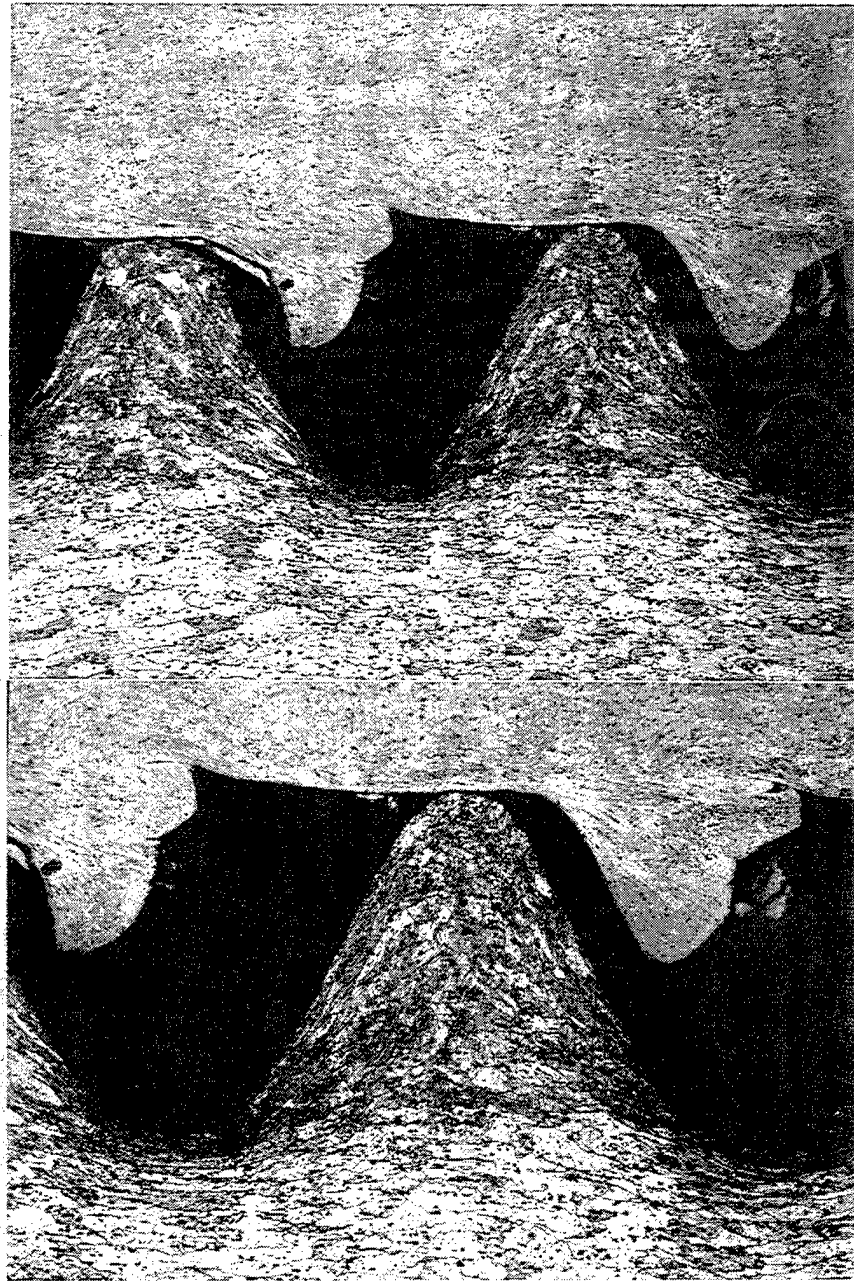
Figure 99. Two magnifications of the etched microstructure of the Huckbolt-pin-locking grooves (bottom of both photographs) and indented interior wall of the 1/4 swaged collar of shear test Specimen D. Note the buildup of the metal in the wall by the penetrated grooves after going beyond the maximum load just before complete shearing of the indented wall took place. The locking grooves of the pin were cold rolled as indicated by the deformed grain structure. Magnification: 40× (top) and 50× (bottom). Keller's etchant.

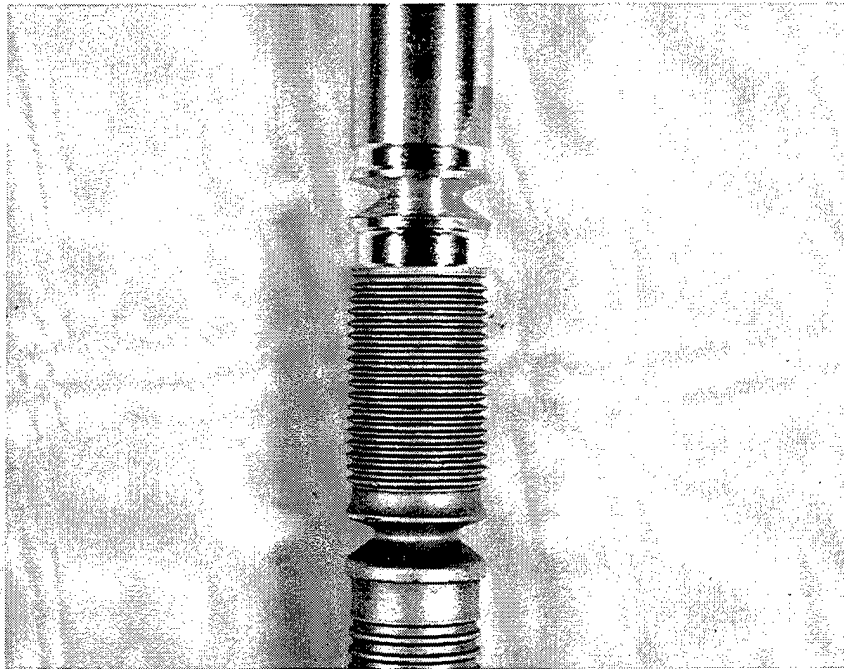
- A third pin sample that has a similar breakaway notch machined on the smooth pin shank (see Figure 102) in order to determine the effect of the notch in the base metal in the area that was not affected by cold rolling as had occurred in the original cold-rolled breakaway notch. The pin sample broke in the machined notch rather than in the cold-rolled notch.

Figure 102. A view of two large breakaway notches on the same Huckbolt pin sample. The upper notch was machined to the same shape and size as the original cold-rolled notch below. The machined notch was located in the smooth shank section of the pin that was not cold rolled.

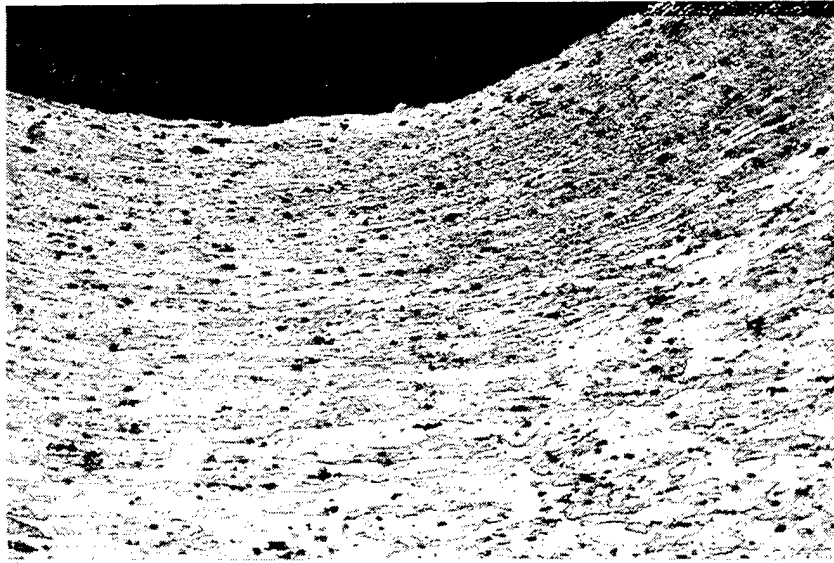
The results of the tensile tests on the 3/4-in-diameter Huckbolt fastener aluminum pin samples are given in Table 8. The average load required to break off the installation stem at the large cold-rolled breakaway notch of two pin samples was 15,840 lb, which translated to 113,790-psi notch tensile strength. Meanwhile, the breaking load and notch tensile strength were 13,340 lb and 90,180 psi, respectively, for the machined notch in the smooth, not cold-rolled shank area of the third pin sample, confirming that the effect of cold rolling the large breakaway notch in the pin had resulted in higher tensile properties. The microstructural examination of the metallographic specimen containing the cross section of the large breakaway notch revealed the elongated grain structure in the notch area as the result of cold rolling as was normally done during the manufacture of the Huckbolt aluminum pins (see Figure 103).

Figure 103. Etched microstructure at the root of the cold-rolled breakaway notch of a Huckbolt aluminum pin sample. Elongated grain structure is seen at the surface edge of the notch, indicative of surface cold rolling. Magnification: 100×. Keller's etchant.

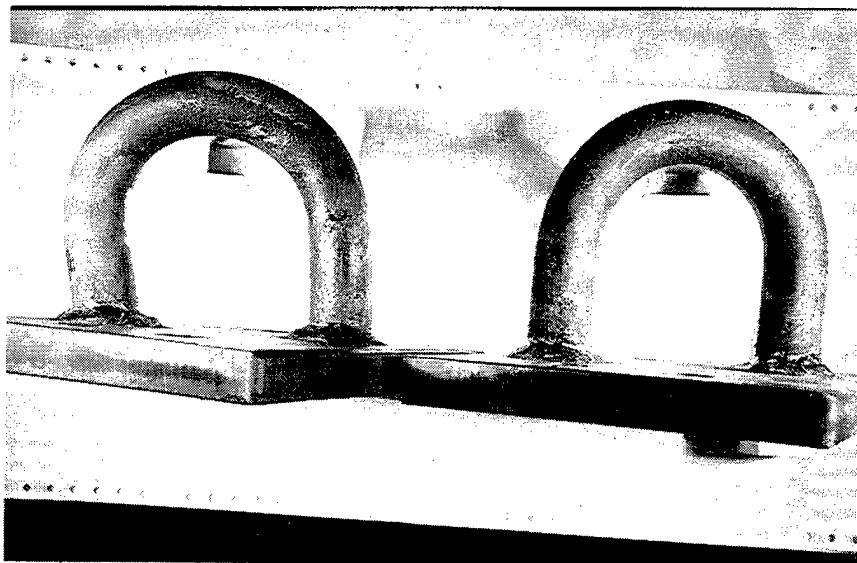
(3) Parallel pull tests (Nos. 5 and 6) whereby the load was applied to the U-shaped bar which was in the vertical position in the testing machine (see Figures 113 and 114 for the test setup). This will cause the upper leg of the bar with the hook under it to be under load up to 40,000 lb maximum. Figure 115 shows the extent of permanent damage to the leg under the hook after the pull tests. According to the load-deflection curves obtained, the upper leg of two devices tested started to bend permanently at about 22,000–23,000 lb.

Figure 115. A view of the tested new lifting device (left) compared to the untested device after the parallel pull test. Note the extent of permanent damage to the left leg of the tested device as the result of the pull test.

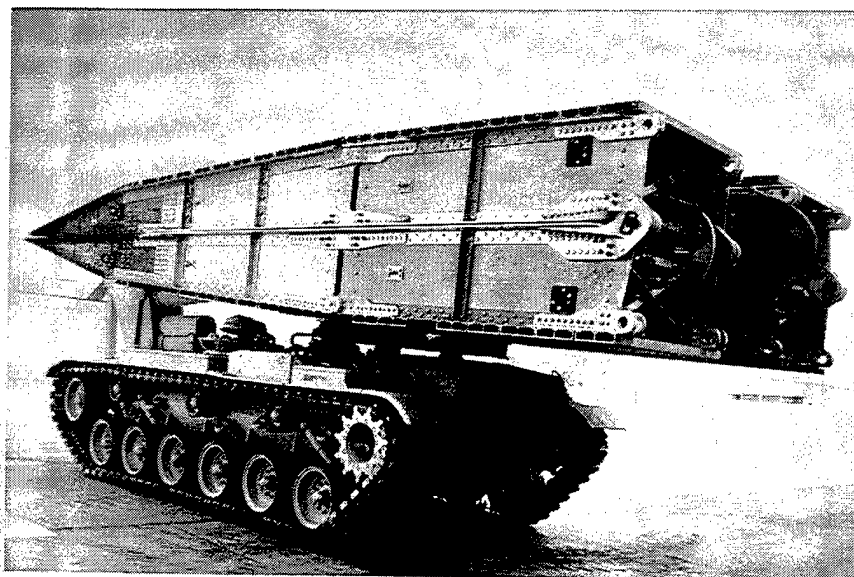
2.16 Inspection and Testing of Two Class 70 Modified AVLBS. Again, based on the findings of the various tests performed at Belvoir by this laboratory during the Class 70 AVLB modification program, ANAD had modified two current Class 60 AVLBS to Class 70 for tests and performance evaluation (see Figure 116). The following modifications were made on both AVLBS at the depot:

Figure 116. A Class 70 Modified AVL B in the folded position on top of the armored vehicle bridge launcher. The bridge is composed of four bridge sections (two females and two males) to form two treadways.

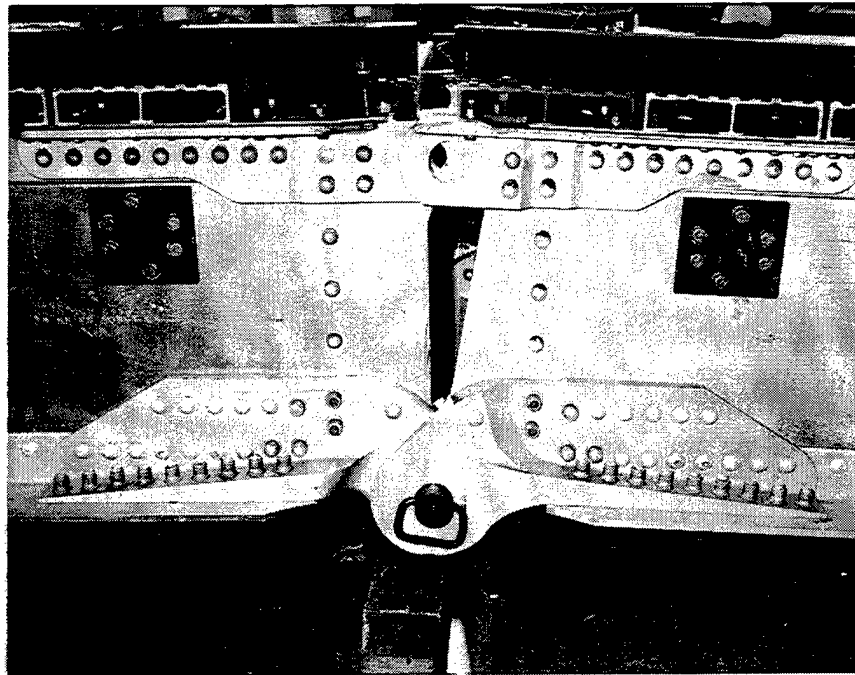
- Larger center hinges to be made of stronger forged aluminum alloy 7050-T7452 to replace alloy 2014-T6 (see Figure 117). Because the hinge forgings would not be available during the modification of two bridges, the hinges at that time were machined from large alloy 7050 plates or forged billets.

Figure 117. Close-up view of the new larger machined aluminum center hinges on the ends of the bottom chords. The hinges were made of stronger aluminum alloy 7050 and were fastened to the aluminum girder plates and larger alloy 7050 bottom chord angles with the Huckbolt fasteners. The flanged aluminum collars are seen on top of the hinge bottom flanges. Note the new steel lifting devices bolted to the girder plate of both bridge sections (the female section is on the right) after the original steel tie-down devices (see Figure 118) were removed. Also note the steel curbs bolted on top of the extruded aluminum deck panels.

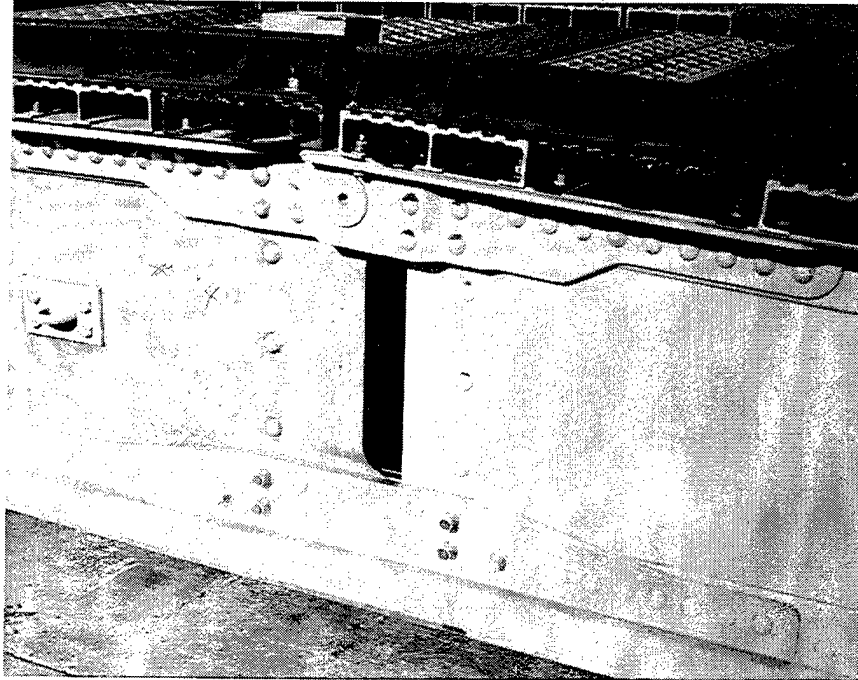
- Larger and stronger bottom chord aluminum alloy 7050-T76511 angles in place of original alloy 2014-T6 angles. The angles were long enough to join the center and end panel assemblies permanently to form one bridge section after the forged bottom aluminum connectors were removed entirely. Alloy 7050 flat bars were used as reinforcements at the joints (see Figure 118).

Figure 118. Close-up view of the aluminum alloy 7050 reinforcement bar fastened to the bottom chord angles and girder plates. It joined the center (left) and the end panel assemblies together permanently after the forged aluminum bottom connectors, similar to the top connectors, were eliminated as part of the Class 70 modification. The bottom chord angles were continuous across the joint. The Huckbolt fasteners were used to fasten the flat bar at the joint. The original steel tie-down device was now bolted to the girder plate of the center panel assembly.
